# 2022 Annual Water Monitoring Report

Dufferin Aggregates Milton Quarry  
Region of Halton

**Subject: 2022 Monitoring Report  
Dufferin Aggregates Milton Quarry, Region of Halton, Ontario**

**2022 Annual Water Monitoring Report  
Dufferin Aggregates Milton Quarry, Region of Halton, Ontario**

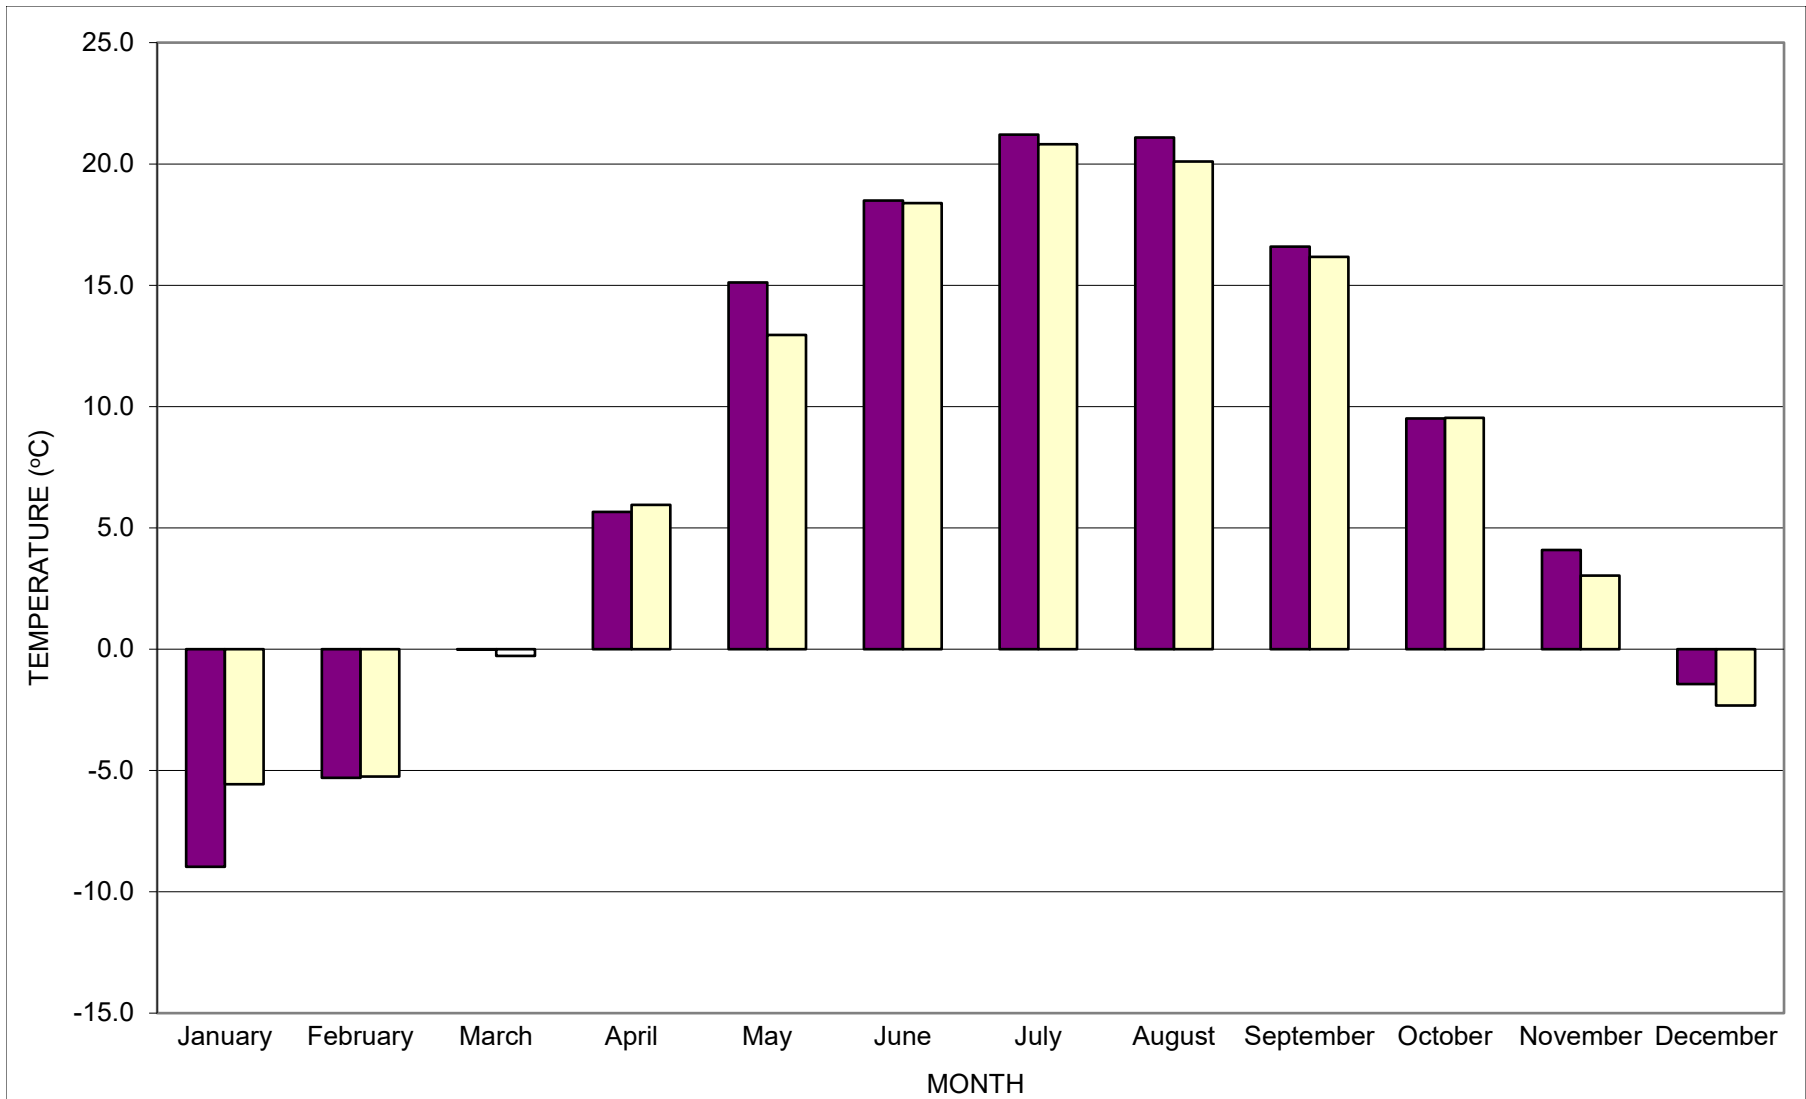
figure 4.1  
 2022 MONTHLY MEASURED AIR TEMPERATURE AVERAGES  
 DUFFERIN MILTON QUARRY  
 Region of Halton, Ontario

■ Measured Milton Quarry 2022  
□ Measured Milton Quarry 26-year Mean

**Note:**  
 Air temperature data was collected at the quarry from 1995 to 1998 and then from 2000 to present.

Cool conditions were observed at the start of winter 2022 in January with monthly average temperatures 3.4°C colder than the long-term average. The balance of the year was slightly warmer than typical, with a net annual result of 0.3°C above average. The coldest day of the year occurred on January 15, 2022 with an average daily temperature of -18.5°C. The hottest average daily temperature of the year was recorded on August 7, 2022 at 26.3°C. The highest and lowest monthly average temperatures in 2022 were in July at 21.2°C and in January at -9.0°C, respectively.

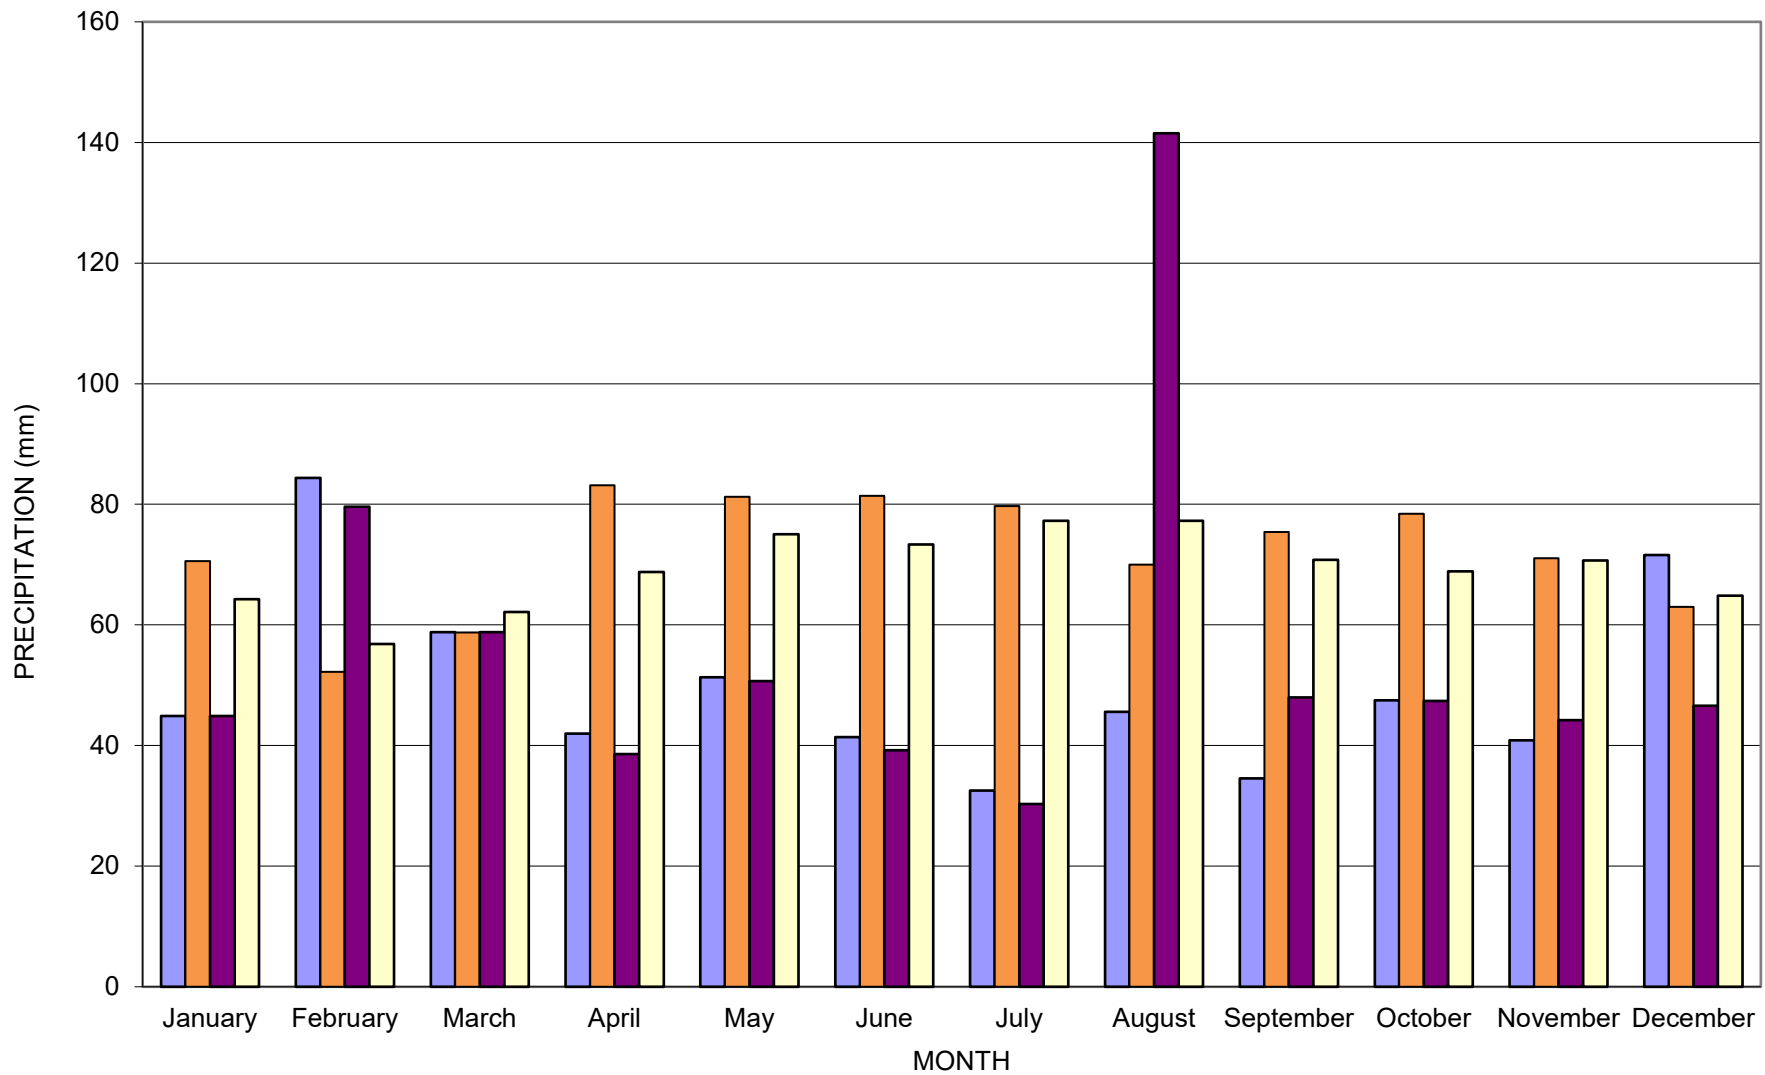
figure 4.2  
**2022 MONTHLY SUPPLEMENTED PRECIPITATION TOTALS**  
**DUFFERIN MILTON QUARRY**  
 Region of Halton, Ontario

- Supplemented Milton Quarry (2022 Total = 595.4 mm)
- Supplemented Milton Quarry - 31- Year Mean (865.0 mm)
- Supplemented Georgetown WWTP (2022 Total = 669.8 mm)
- Supplemented Georgetown WWTP - 140-Year Mean (830.1 mm)

average. Conditions at the start of the year in January were significantly drier than the long-term average, and almost half of the mean precipitation was recorded (45 mm recorded versus the mean of 70 mm), followed by a significantly wetter than average February, exceeding the long-term average by about 32 mm. Average conditions were observed in March, whereas the rest of the year excluding December experienced drier conditions than the long-term average. This made 2022 the driest year on record for Milton Quarry since monitoring records began in 1991.

The Georgetown WWTP total annual precipitation for 2022 (670 mm) was lower than its long-term average (1991 to 2021), by approximately 160 mm. The 2022 Georgetown WWTP precipitation data reveals the significant impact that isolated storms can have on the area. During the months of February and August, the Georgetown WWTP monthly data exceeded the precipitation observed at the Milton, as well as both long-term averages. A clear difference between Georgetown WWTP and the Milton Quarry precipitation for some months in 2022 can be seen on Figure 4.2; however, most months are very similar. A comparison of precipitation at Milton Quarry and the Georgetown WWTP is presented in Appendix E Table E.3.

While some month-to-month variability was present, conditions were typical through March 2022. Subsequently, a significant reduction in precipitation was observed for the balance of the year. Total precipitation was recorded to be 595 mm in 2022 and was lower than the long-term average by approximately 270 mm. Observations in 2022 indicate it was the driest year recorded since monitoring commenced in 1991.

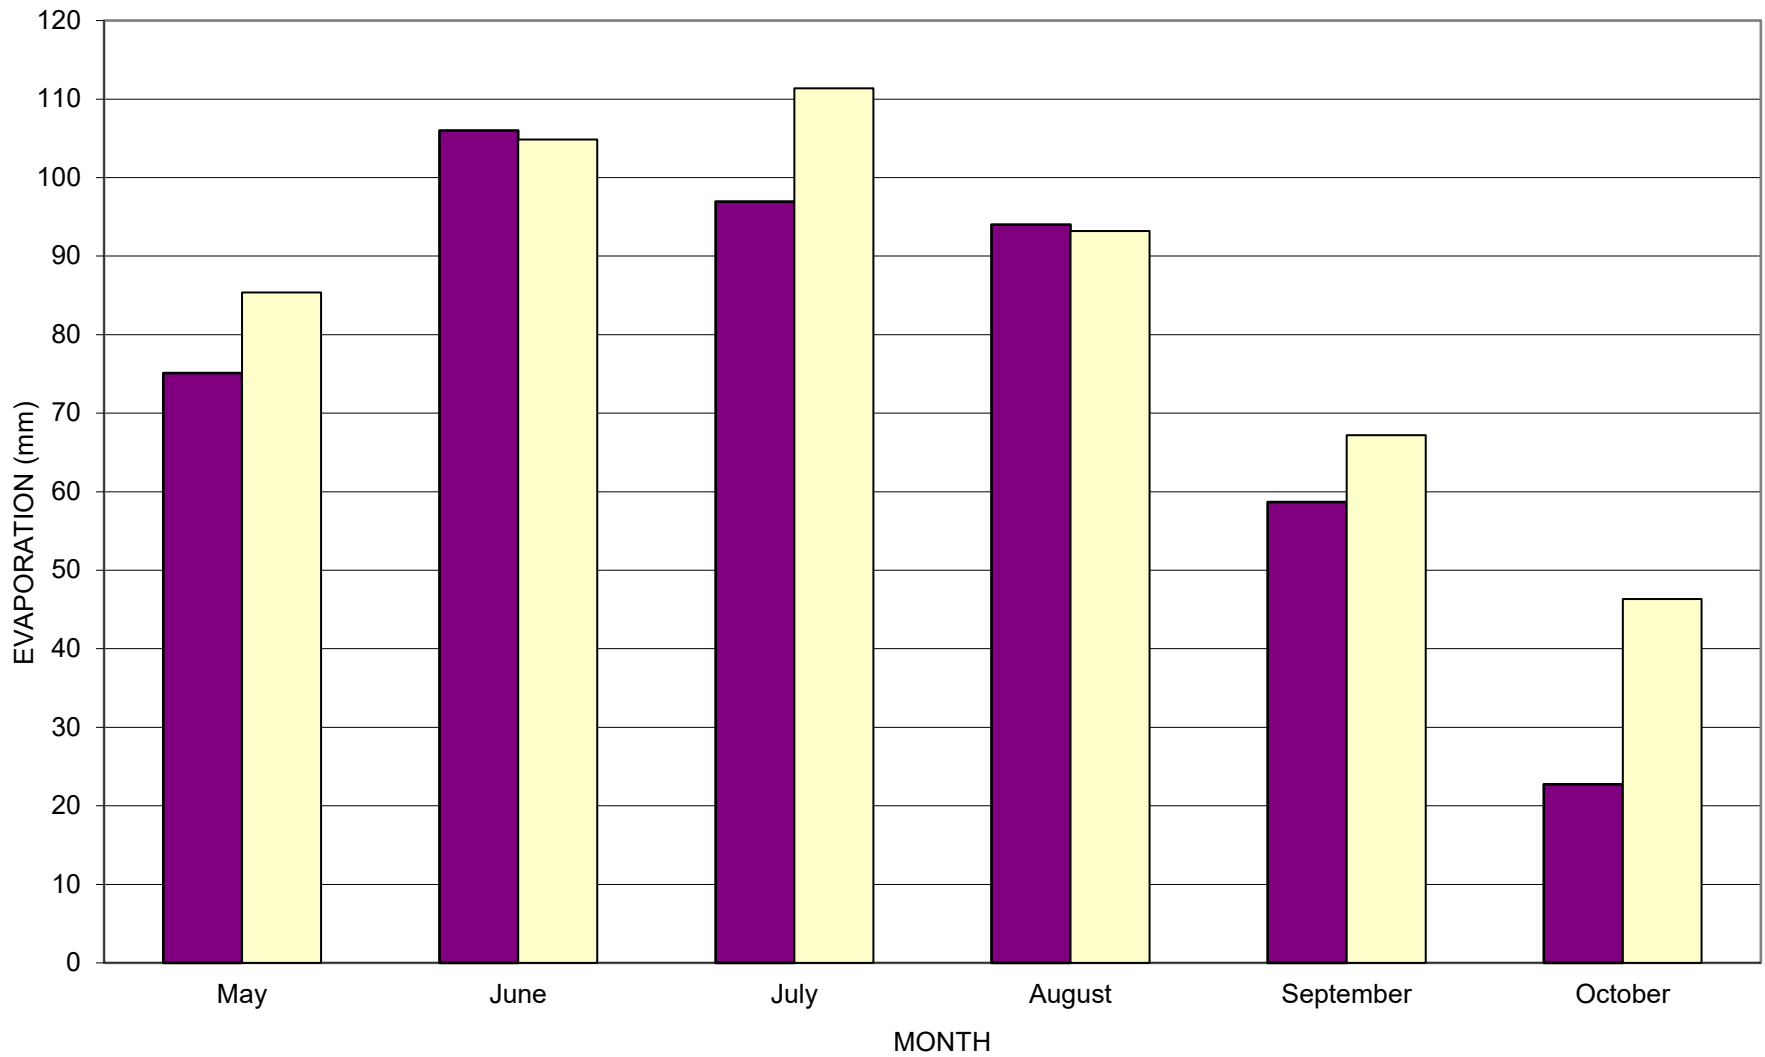
figure 4.3  
 2022 MONTHLY MEASURED LAKE EVAPORATION TOTALS  
 DUFFERIN MILTON QUARRY  
 Region of Halton, Ontario

■ Measured Lake Evaporation (2022 Total = 489.0 mm)

□ Measured Lake Evaporation Average (550.4 mm)

The annual lake water surplus/deficit, which is the difference between the precipitation and lake evaporation is -12 mm, indicating a water deficit over the lake area for the year. The deficit observed in 2022 is much lower than the long-term average surplus of 209 mm. Historical annual precipitation surplus data is presented in Appendix E Table E.4.

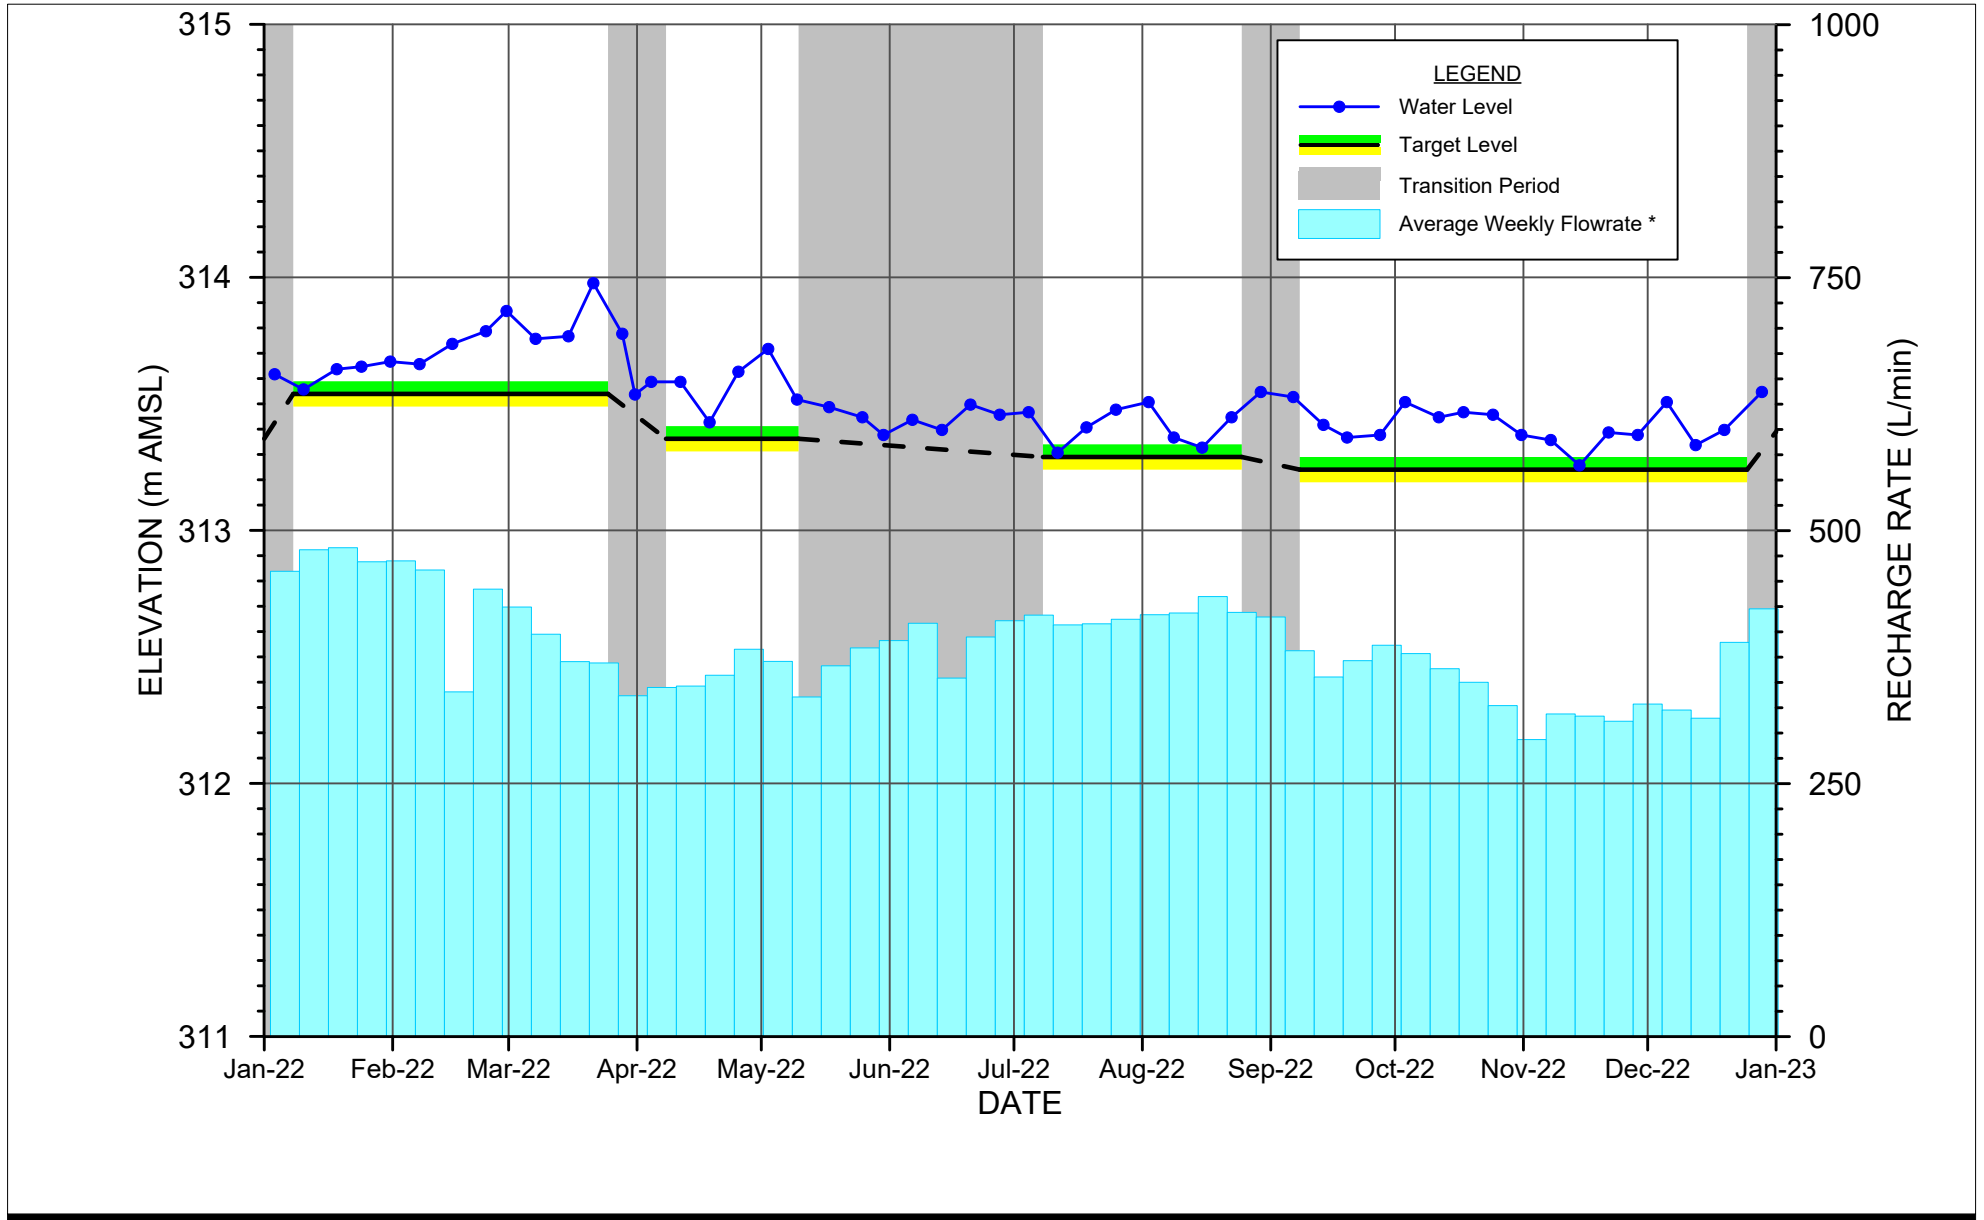
FIGURE 5.3

\* Includes flow from RW104C-09, RW104D-07, RW105A-09, RW105B-07, RW105C-13, RW105D-13, RW106A-07, RW106A-13, and RW106B-13

TRIGGER WELL - BH57-III  
NORTH QUARRY

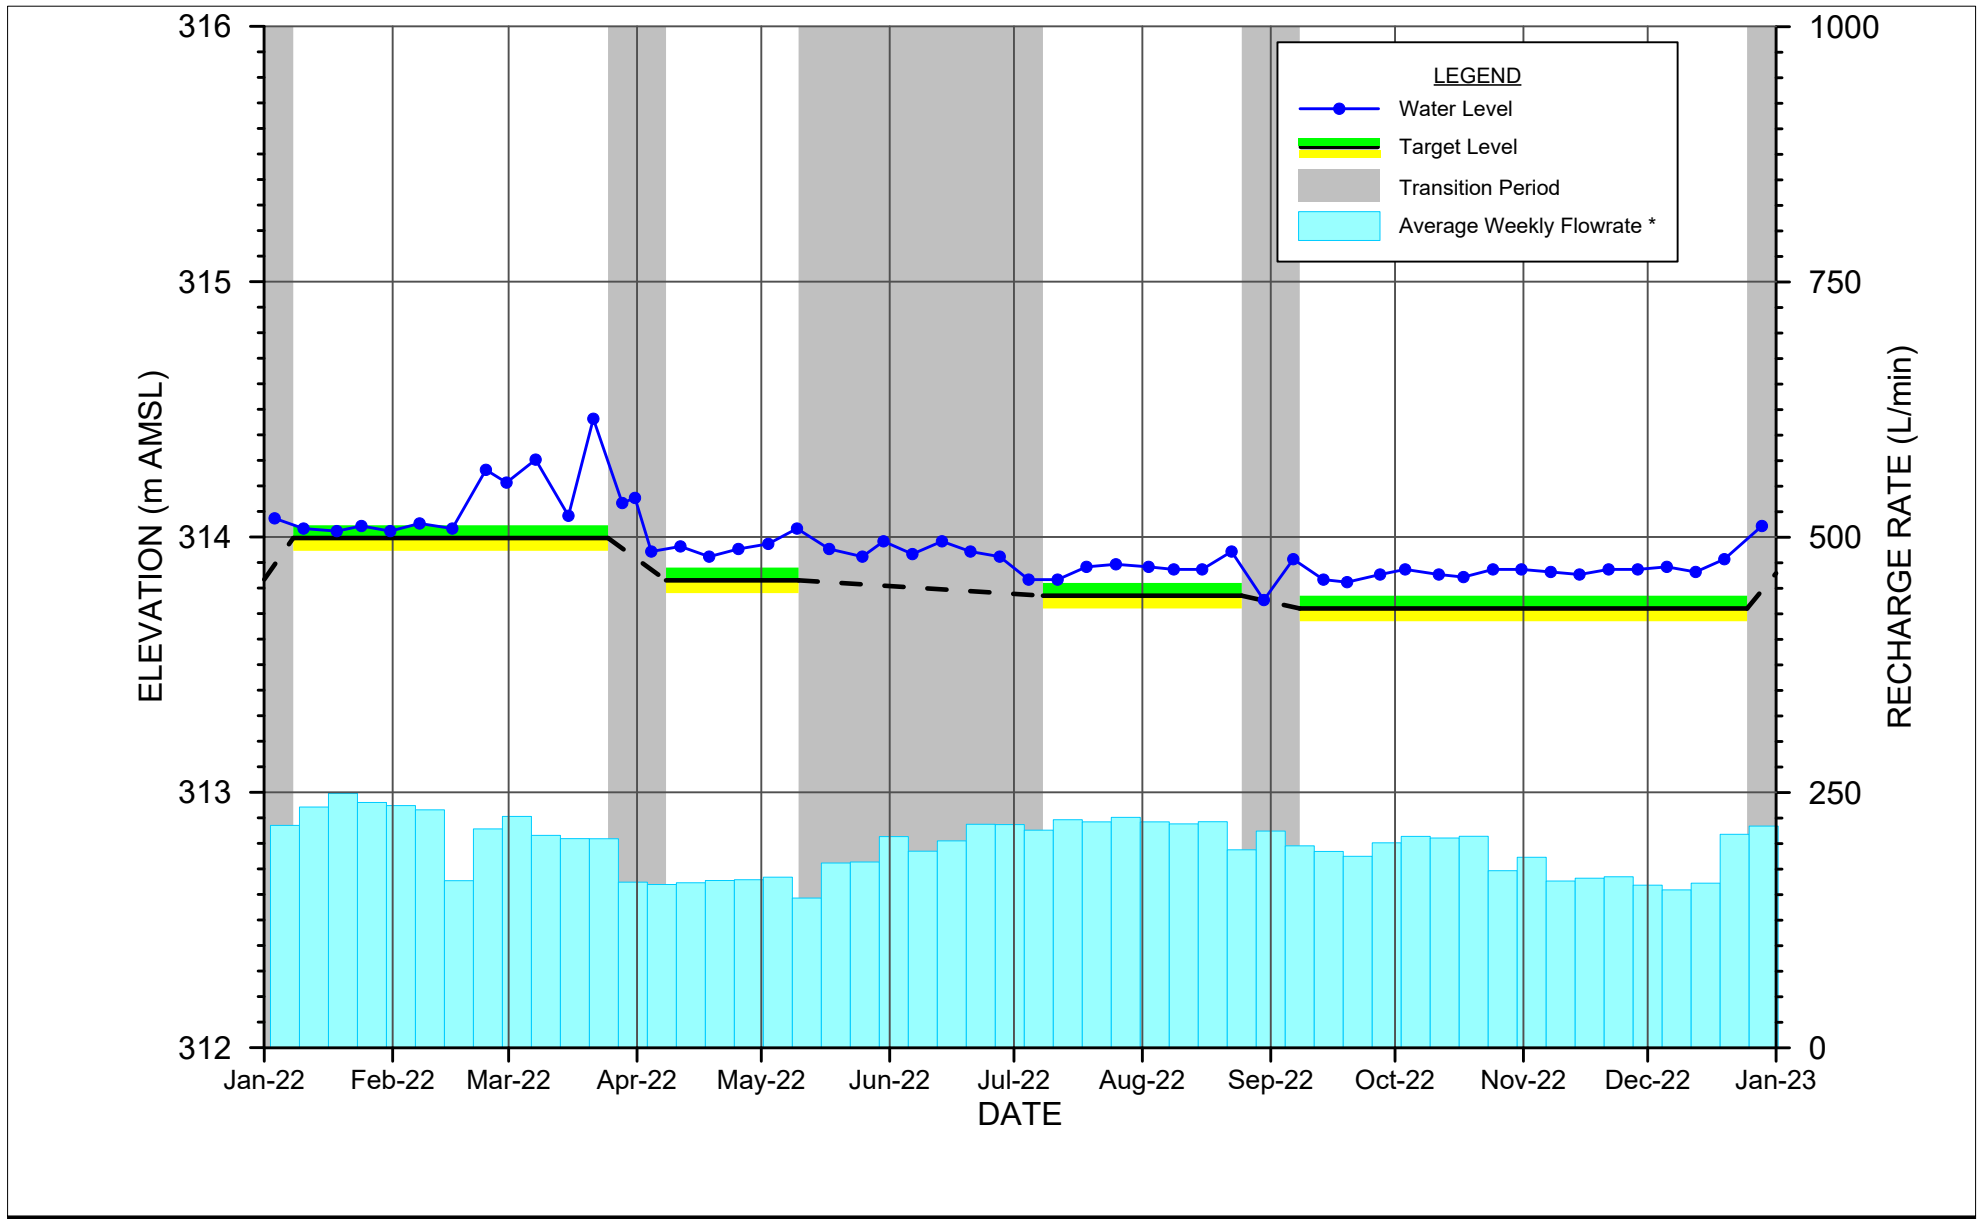
FIGURE 5.4

\* Includes flow from RW105A-09, RW106A-13, RW106B-13, RW106C-11, RW106D-07, RW106D2-15, RW107A-07, and RW107D-09

TRIGGER WELL - BH59  
NORTH QUARRY
