# VISUAL IMPACT ASSESSMENT

PROPOSED MILTON QUARRY EAST EXTENSION

Town of Halton Hills, Ontario

**November 2021**

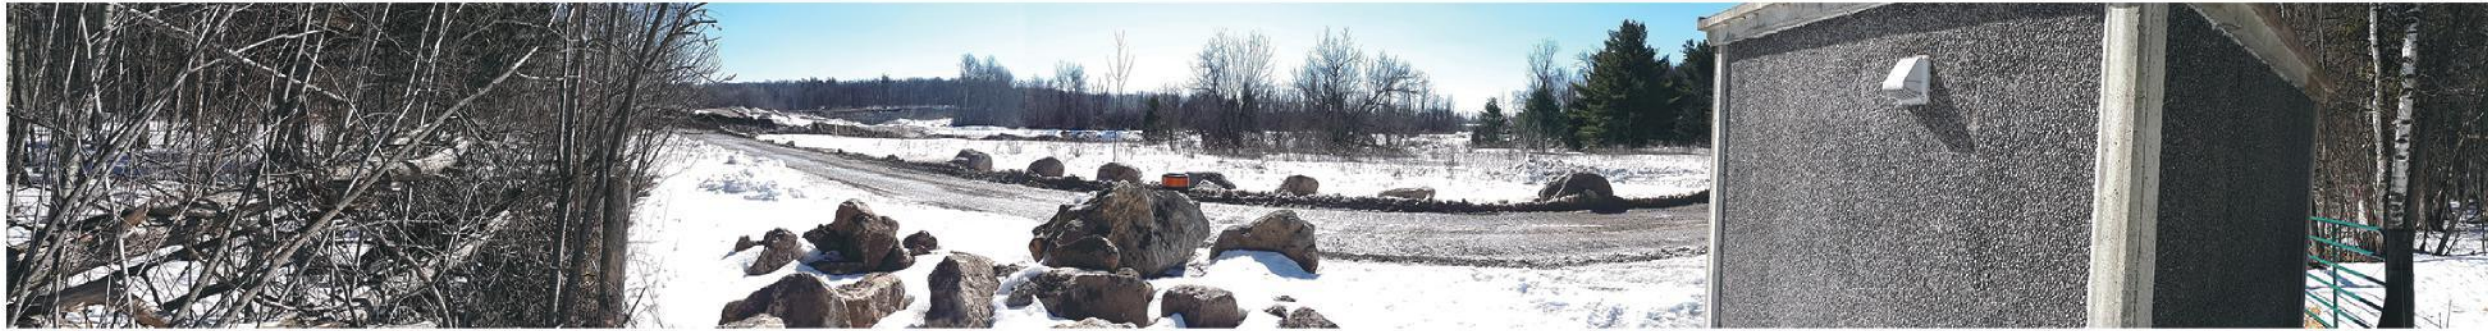
Photo 22: Along Water Monitoring Side Trail on Dufferin Land taken towards proposed extension.

<b>Photo 22</b>	Water Monitoring Side Trail on Dufferin Land	Clear views into Dufferin property which are of largely open fields and roads used for quarry operations. Distant tree line provides some screening of subject lands.	None	Limited removal of some distant trees. Possible views of machinery along top of quarry during site preparation. Distant Views into the quarry possible.	Mitigation measures not required.

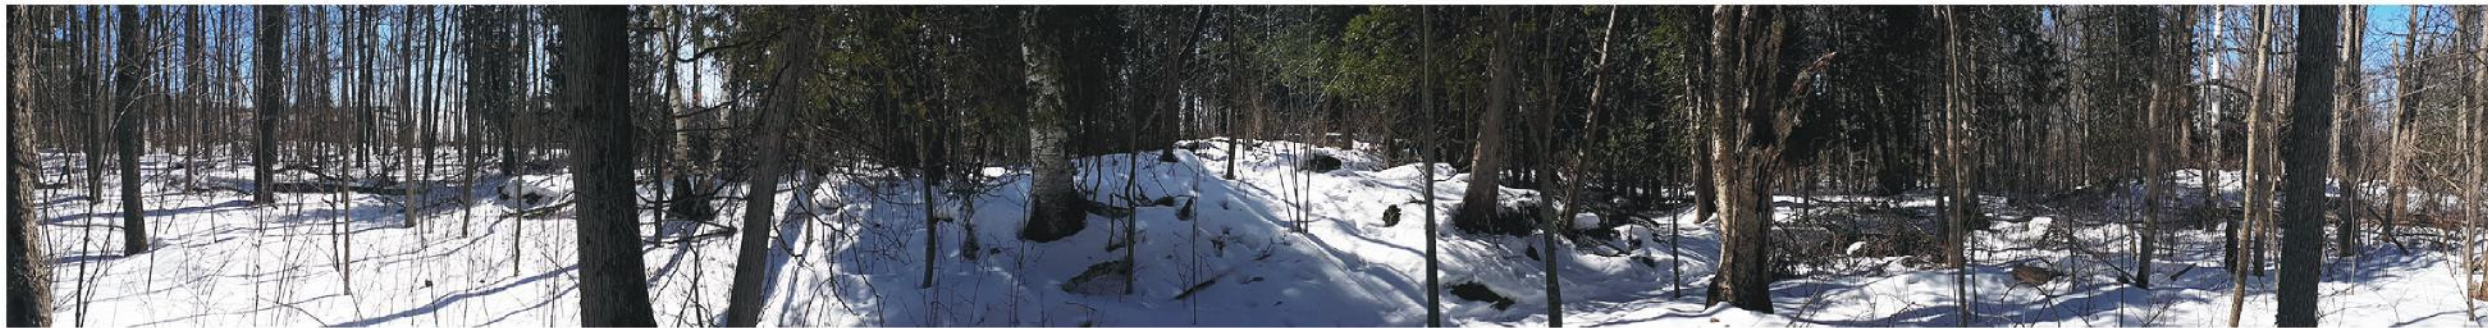
Photo 23: Along Water Monitoring Side Trail on Dufferin Land taken towards proposed extension.

<b>Photo 23</b>	Water Monitoring Side Trail on Dufferin Land	Views of mixed forest and understorey. Rocky outcroppings rise around the trail. Screened views into Dufferin property possible, but no views of subject lands.	None	-	Mitigation measures not required.
<b>Photo 24</b>	Hilton Falls Side Trail	Views of mixed forest and understorey. Rocky outcroppings rise around the trail. Screened views into Dufferin property possible, but no views of subject lands.	None	-	Mitigation measures not required.
<b>Photo 25</b>	Hilton Falls Side Trail	Views of deciduous forest and understorey. Rocky outcroppings rise around the trail. Screened views into Dufferin property possible, but no views of subject lands.	None	-	Mitigation measures not required.
<b>Photo 26</b>	Hilton Falls Side Trail	Views of deciduous forest and understorey. Rocky outcroppings rise around the trail. Screened views into Dufferin property possible, but no views of subject lands.	None	-	Mitigation measures not required.

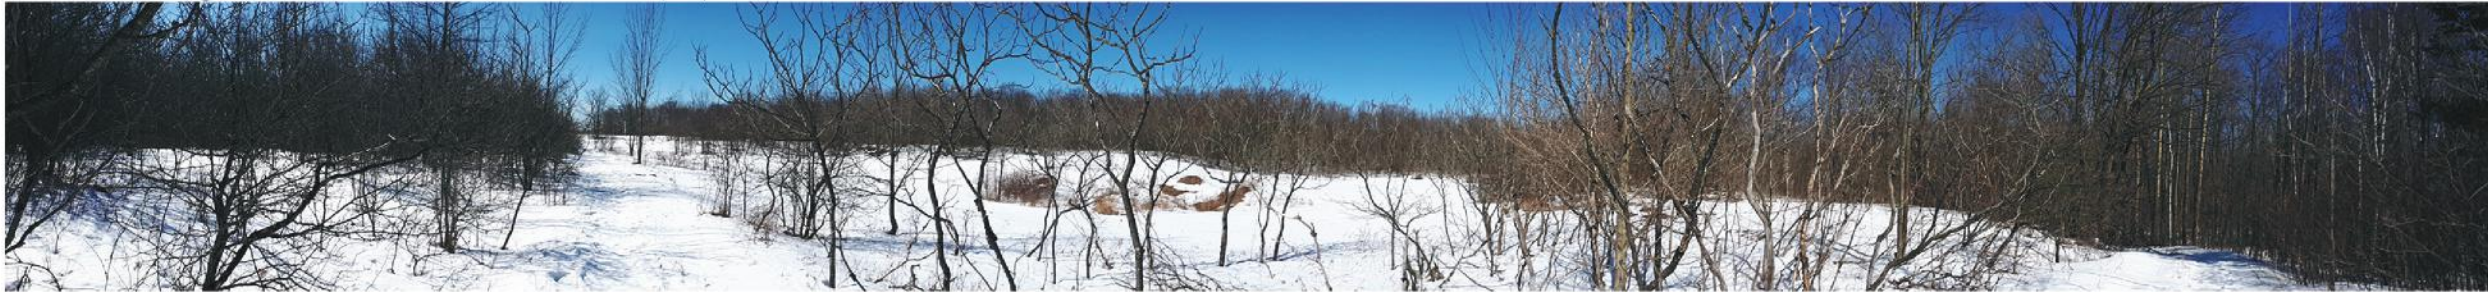
Photo 27: Along Water Monitoring Side Trail on Dufferin Lands taken towards proposed extension.

<b>Photo 27</b>	Water Monitoring Side Trail on Dufferin Land	Open views of subject lands with dense forest along the periphery. Extraction activities will be clearly visible in distance.	None	Views only present from private land that can be accessed by coming off trail. Area to be fenced off in the	Mitigation measures not required.

future to prevent access and potential views. .
<b>Photo 28</b>	Hilton Falls Side Trail	Views of existing dense deciduous forest provides full screening of potential views.	None	-	Mitigation measures not required.
<b>Photo 29</b>	Hilton Falls Side Trail	Views of existing marsh and dense deciduous forest. Small rolling hills provide full screening of potential views.	None	-	Mitigation measures not required.
<b>Photo 30</b>	Bruce Trail	Views of existing dense deciduous forest and high topography along trail provides full screening of potential views.	None	-	Mitigation measures not required.

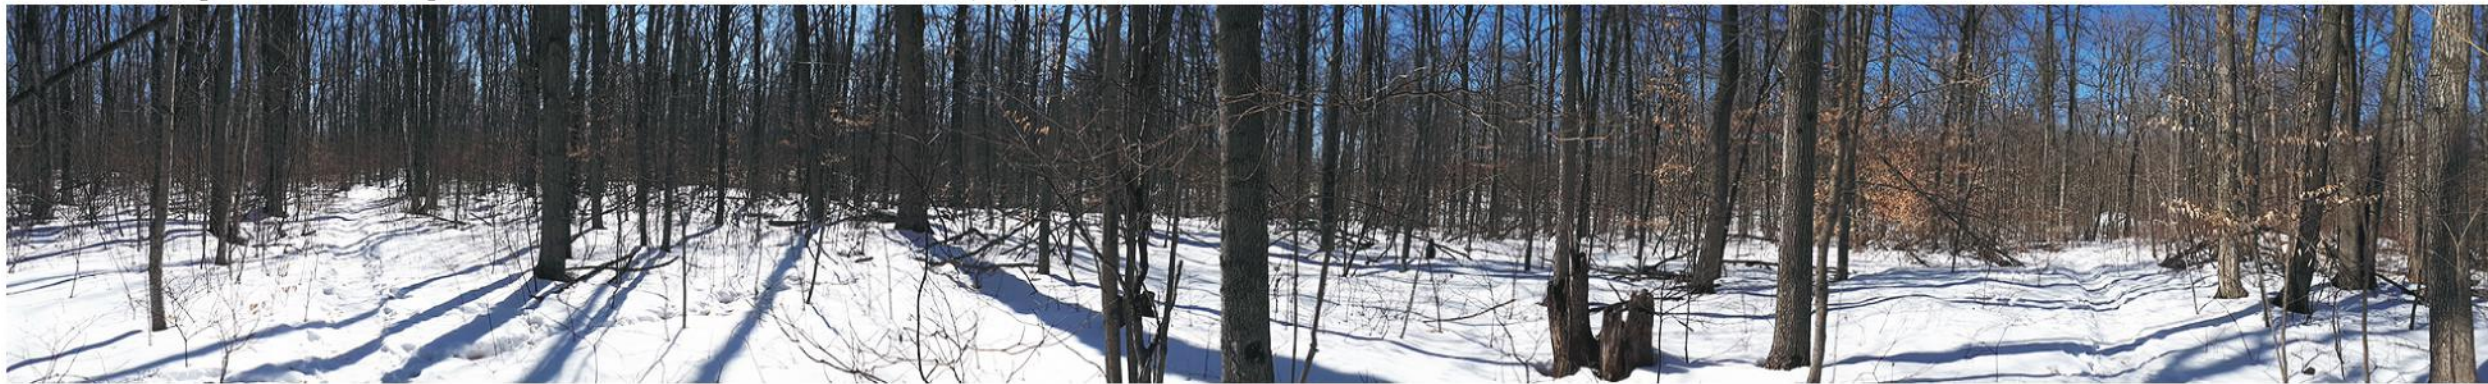
Photo 28: Along Hilton Falls Side Trail taken towards proposed extension.

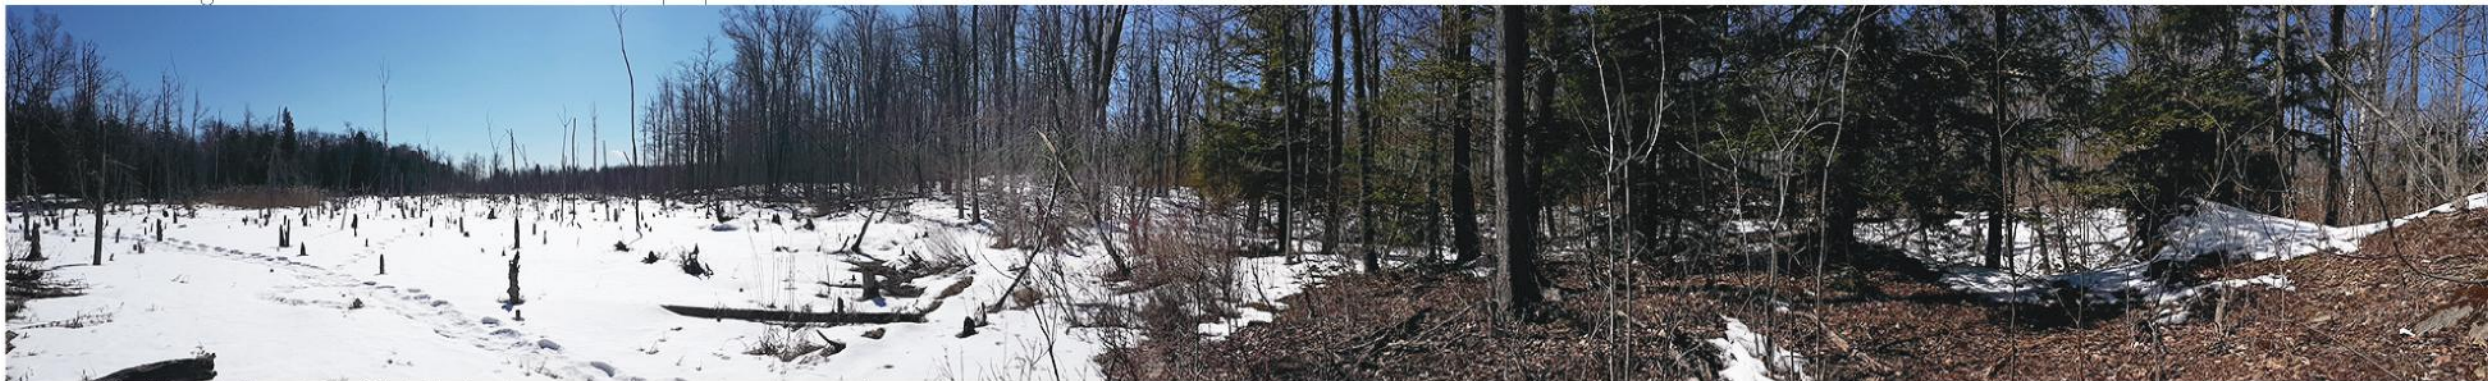
Photo 29: Along Hilton Falls Side Trail taken towards proposed extension.
